PELICAN STATE INSPECTION, L.L.C.

Home Inspection Report

BUILDING TYPE: 1 Family New Construction
STORIES: 2
FOUNDATION TYPE: Slab on grade

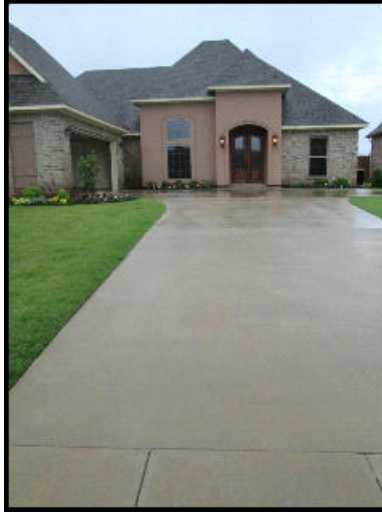
DRIVEWAY

Concrete
Cracks noted are typical.

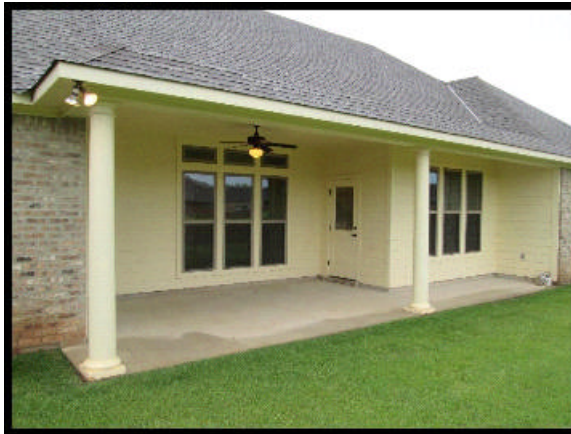
PATIO

Concrete
Yes
Same as structure
The patio & roof support post appeared to be functional. **Cracks noted were typical.**

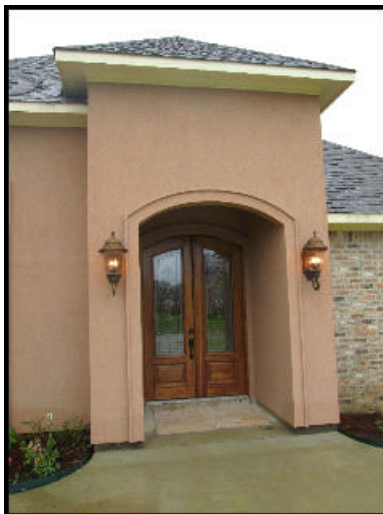
TYPE: Concrete
PORCH LIGHTED: Yes
PORCH COVER TYPE: Same as structure
PORCH CONDITION: The porch appeared to be functional.

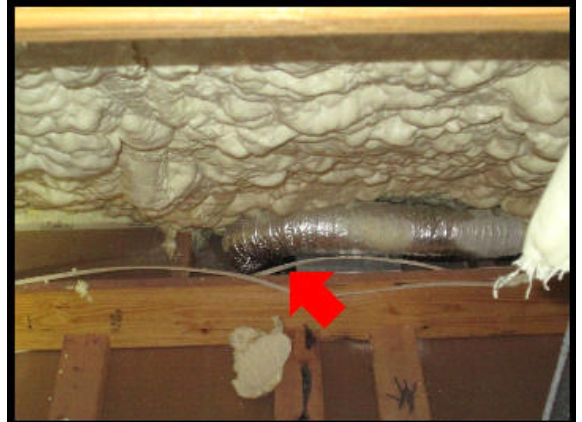
Two of the attic vent fan vent lines were disconnected at the fans.

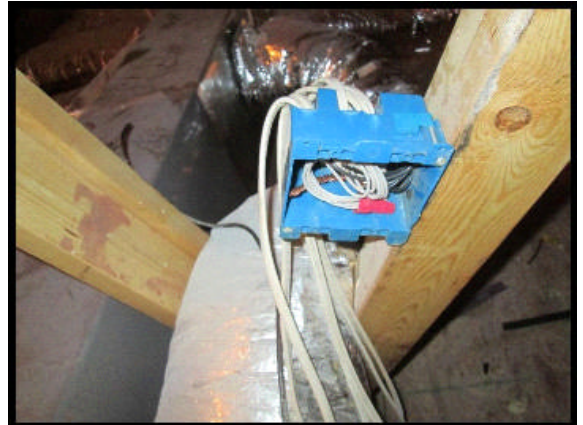
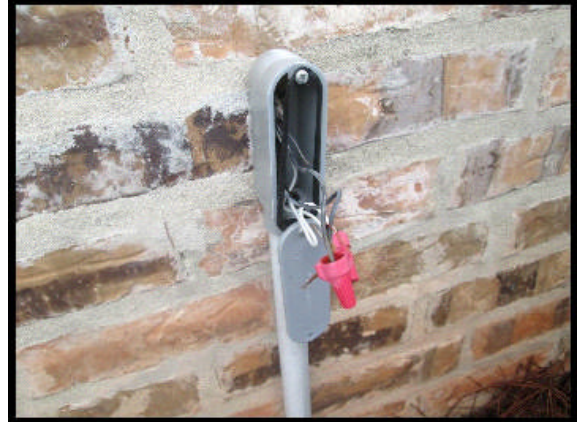
CIRCUIT WIRING CONDITION:

There were 2 junction boxes noted with missing covers.

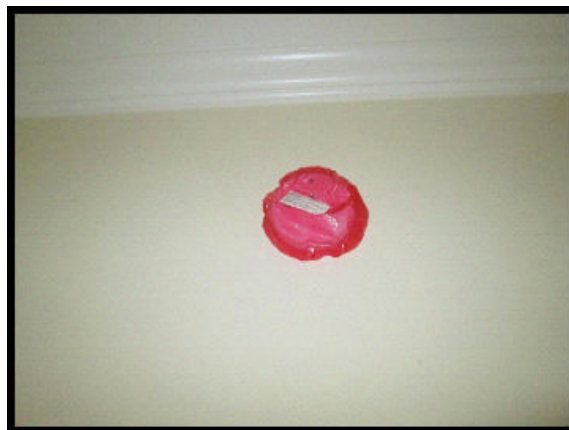
SMOKE DETECTORS:

The structure was equipped with smoke or heat detectors. They should be tested periodically in accordance with the manufacturer's specifications. This does not imply that there was adequate coverage by the existing detector(s). The existing smoke detectors were not tested, but they are only noted as to presence. The inspector did not test the smoke detectors because they may work today but not work when you need them to work. This is why it is important for **you** to test them on a regular basis, monthly at least. **Dust covers were noted on some of the smoke detectors that should be removed once the house is occupied.**

Example pictured.

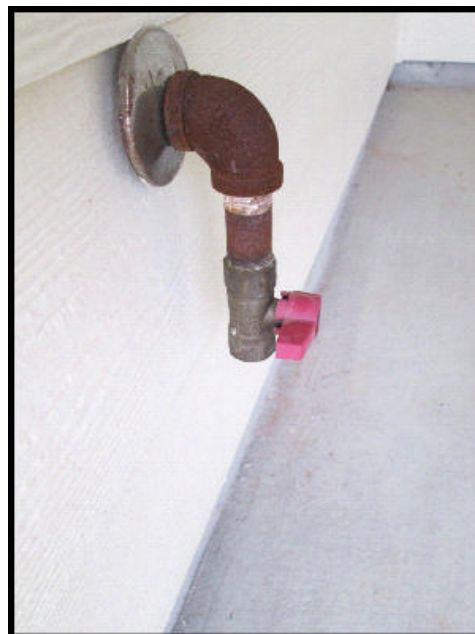
FUEL DISTRIBUTION PIPING CONDITION: The visible gas piping appeared functional. The piping was not pressure tested. **It is recommended that the gas valve at the rear of the house have a plug installed until it is used to prevent accidental discharge.**

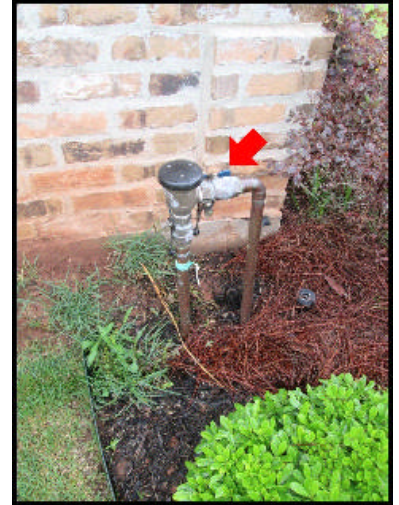
WATER SHUT OFF

The water shut off was located on the backflow preventer.

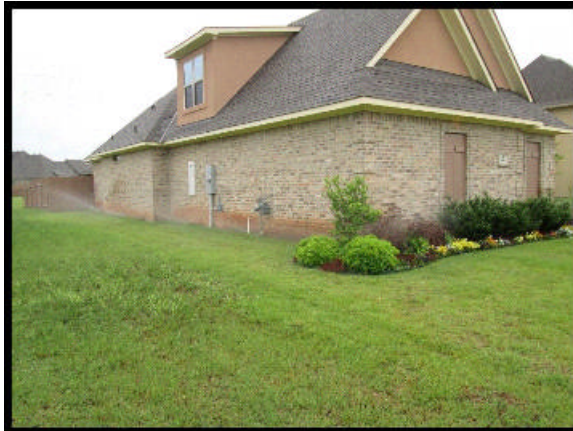
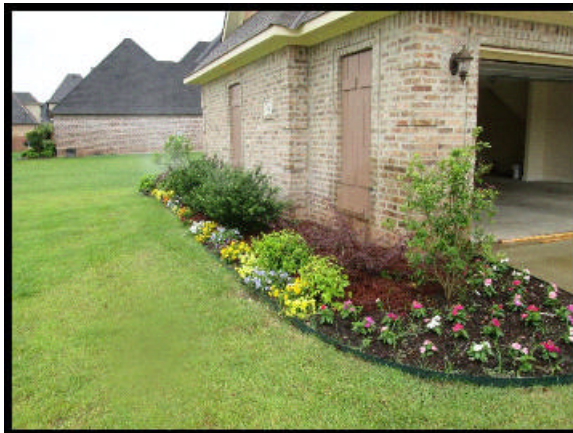
There was a head noted in this zone that needed adjustment. It does not raise height enough above the ground.

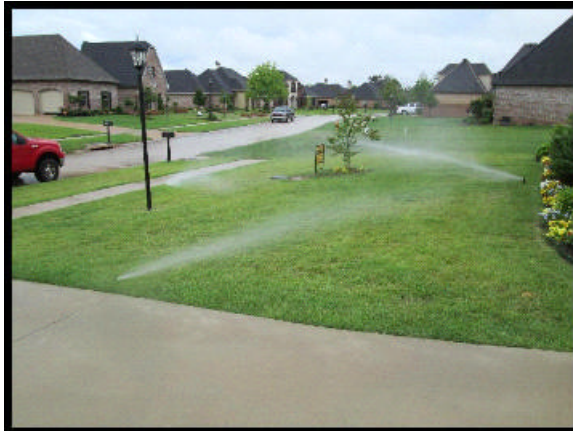
ZONE #2

This zone was functional.

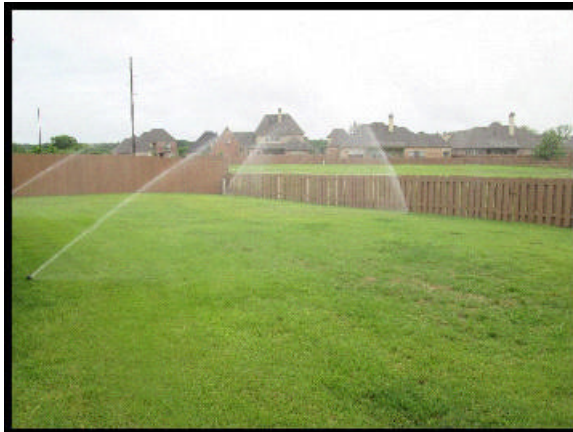
ZONE #3

This zone was functional.

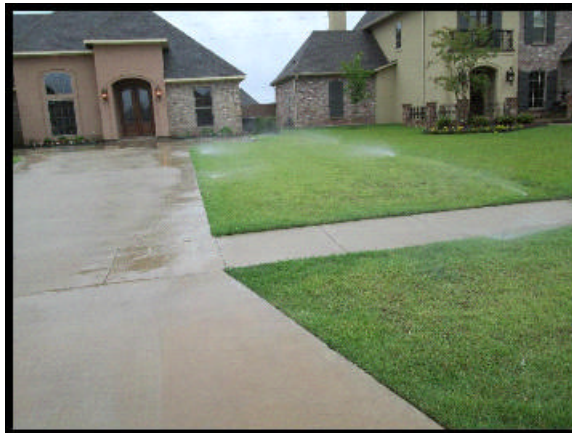
There were 2 heads noted in this zone that needed adjustment. It does not raise height enough above the ground. Example pictured.

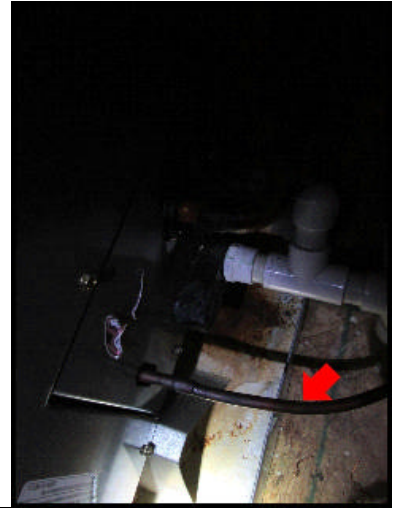
INSULATION WRAP ON THE SUCTION LINE: **The insulation wrap for the suction line to one of the condensers/compressors was missing in a section at the exterior and in the attic.**

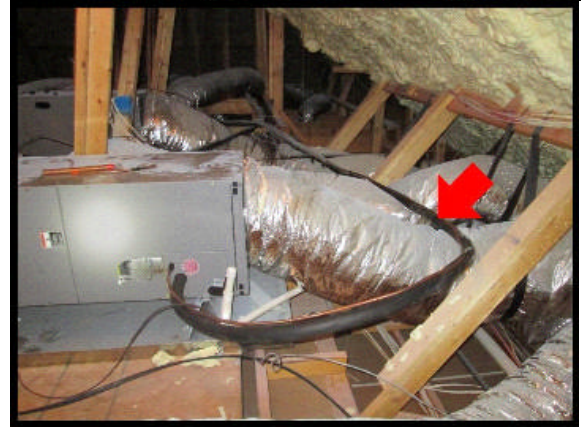
FREON LINE SET:

Support strapping should be installed on the pictured freon line set in the attic.

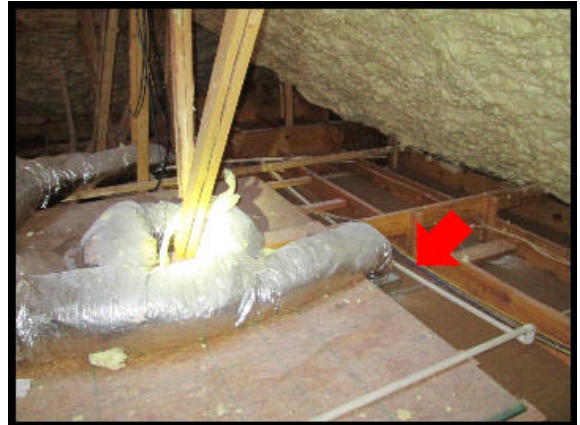
SECONDARY CONDENSATE LINE:

One of the secondary condensate drain lines was not properly sloped in the attic.

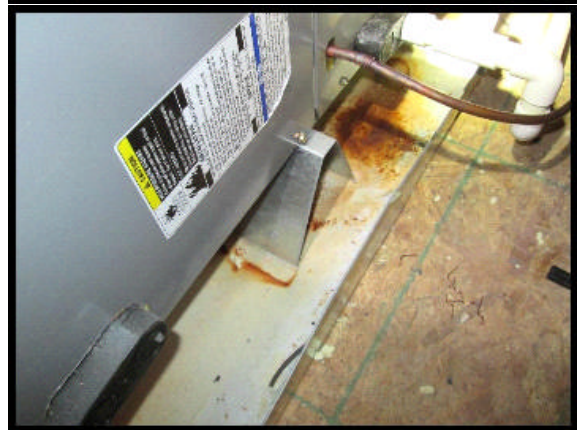
SECONDARY DRAIN PAN CONDITION:

There was a small amount of water standing on one of the secondary drain pans.

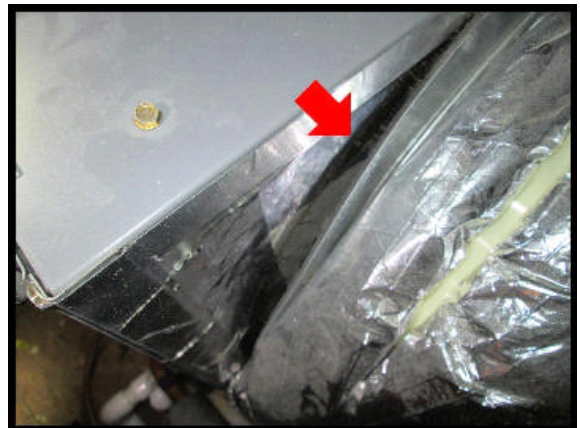
The ductwork consist of flexible ducts
One of the return air ducts was partially disconnected from its plenum in the attic.

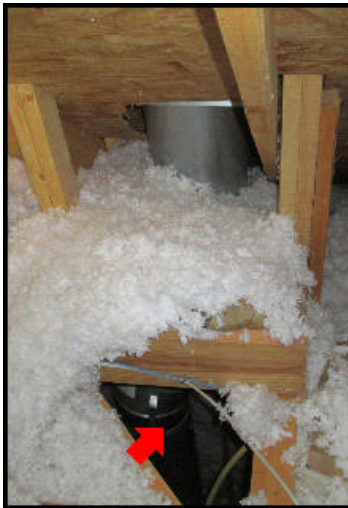
FIREPLACE #1

LOCATION OF FIREPLACE: Living Room
TYPE OF FIREPLACE: Factory built with a metal formed firebox designed for vented gas logs only.
FIREPLACE FUEL: The fireplace was appeared to be designed to burn wood.
FIREBOX CONDITION: The firebox appeared to be sound and useable in its current condition.
DAMPER CONDITION: The flue damper appeared to be functional and fully adjustable.
EVIDENCE OF DRAFTING PROBLEMS: The fireplace has not been used. The inspector could not determine if there are drafting problems.
FLUE CONDITION FROM FIREBOX: The visible portions of the chimney flue appeared to be satisfactory.
EXTERIOR STACK MATERIAL: The exterior fireplace chase was wood framed and enclosed with siding material similar to the structural siding.
EXTERIOR STACK CONDITION: The exterior stack appeared to be in satisfactory condition.
FLUE: The fireplace flue was lined with metal. **The chimney did not have the proper fireblocking as it passes in to the attic.** All spaces between chimneys and floors and ceilings through which chimneys pass shall be fireblocked with noncombustible material securely fastened in place. **Insulation was also in direct contact with the flue pipe. The metal flue requires 1 1/2 inches of clearance from building materials and insulation.**

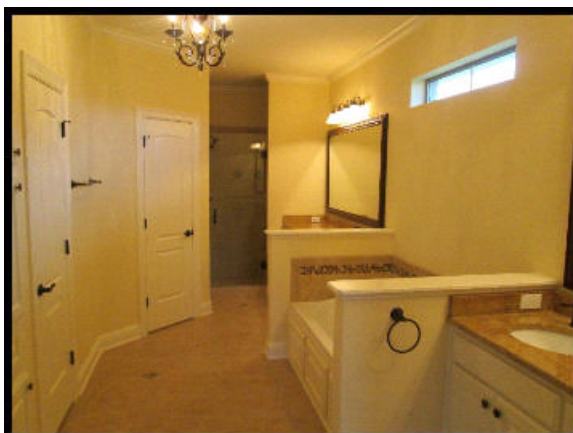
ENTRY DOOR:	The entry door was functional.
WALLS:	The walls appeared to be satisfactory.
CEILING:	The ceiling appeared to be satisfactory.
FLOOR:	The flooring appeared to be satisfactory.
LIGHTING:	The lighting appeared to be functional at the time of the inspection.
VENTILATION FAN:	There was an exhaust fan installed in this bathroom, and it is appeared to perform satisfactorily.
ELECTRICAL OUTLETS:	The outlets tested appeared to be correctly wired and grounded.
GROUND FAULT INTERRUPT OUTLETS:	The bathroom outlets were Ground Fault protected. The GFCI outlet / breaker protecting the bathroom was tested and was functional.
VANITY CABINET:	The visible portions of the vanity cabinet and top in this bathroom appeared to be satisfactory.
BASIN AND DRAIN FIXTURE:	The basin and drainage fixture appeared to be satisfactory.
FAUCET AND SUPPLY LINES:	Faucets and supply lines appeared to be satisfactory with no leaks noted.

TOILET CONDITION:	The toilet appeared to be functional.
TUB:	There was a spa tub installed. The tub was filled with water and the jets activated to observe for proper action. The tub appeared to function properly. The spa tub was GFCI protected.
TUB STOPPER:	The tub mixing valve and stopper appeared to be in satisfactory condition.
SHOWER:	The shower, shower head, and mixing valves all appeared to perform as required.
SHOWER PAN:	This was a visual inspection of the readily accessible portions of the shower stall and was not invasive. Therefore, it is a limited inspection and may not have noted any hidden defects. Flood testing of the shower pan was not included as part of this inspection. The shower was ran for about 15 minutes and there were not any visible leaks.
SHOWER WALLS:	The walls appeared to be in satisfactory condition.
SHOWER DRAIN:	The tub/shower appeared to drain at an acceptable rate.

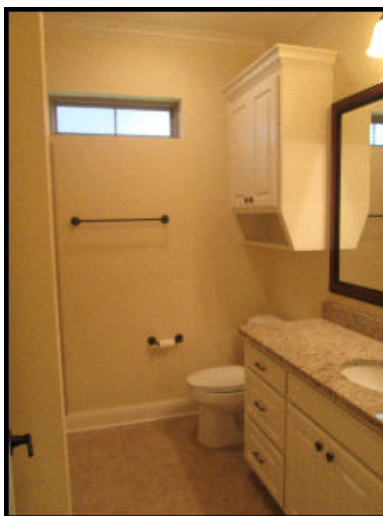
ENTRY DOOR:	The entry door was functional.
WALLS:	The walls appeared to be satisfactory.
CEILING:	The ceiling appeared to be satisfactory.
FLOOR:	The flooring appeared to be satisfactory.
LIGHTING:	The lighting appeared to be functional at the time of the inspection.
VENTILATION FAN:	There was an exhaust fan installed in this bathroom, and it is appeared to perform satisfactorily.
ELECTRICAL OUTLETS:	The outlet tested appeared to be correctly wired and grounded.
GROUND FAULT INTERRUPT OUTLETS:	The bathroom outlets were Ground Fault protected. The GFCI outlet / breaker protecting the bathroom was tested and was functional.
VANITY CABINET:	The visible portions of the vanity cabinet and top in this bathroom appeared to be satisfactory.
BASIN AND DRAIN FIXTURE:	The basin and drainage fixture appeared to be satisfactory.
FAUCET AND SUPPLY LINES:	Faucets and supply lines appeared to be satisfactory with no leaks noted.

TOILET CONDITION:	The toilet appeared to be functional.
TUB:	The tub / shower drained slow.
TUB MIXING VALVE & STOPPER:	The tub mixing valve and stopper appeared to be in satisfactory condition.
SHOWER:	The shower, shower head, and mixing valves all appeared to perform as required.
TUB/SHOWER WALLS:	The walls appeared to be in satisfactory condition.
HEAT SOURCE:	There was a heat source in this room.

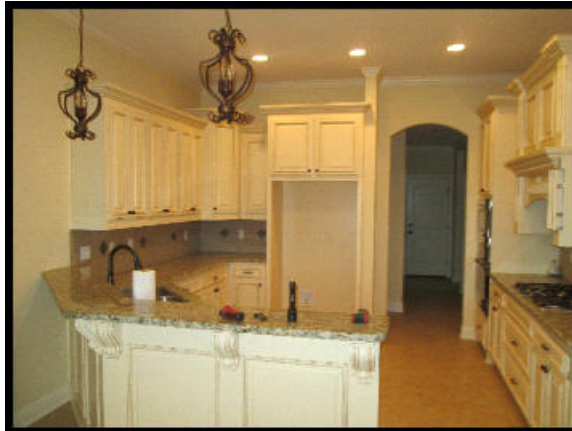
WALLS:	The walls appeared to be satisfactory.
COUNTERTOPS:	The countertops in the kitchen appeared to be satisfactory.
CEILING:	The ceiling appeared to be satisfactory.
FLOOR:	The flooring appeared to be satisfactory.
LIGHTING:	The lighting appeared to be functional at the time of the inspection.
ELECTRICAL OUTLETS:	The outlets tested appeared to be correctly wired and grounded.
GROUND FAULT INTERRUPT OUTLETS:	The kitchen outlets were Ground Fault protected. The GFCI outlet / breaker protecting the kitchen was tested and was functional.
CABINETS, DRAWERS, AND DOORS:	The representative number of cabinets, doors, and drawers were checked and they appeared to be satisfactory in both appearance and function.
FAUCET AND SUPPLY LINES:	Faucets and supply lines appeared satisfactory with no leaks noted.
SINK AND DRAIN LINES:	The sink and drainage lines appeared to be satisfactory.
FOOD WASTE DISPOSAL:	The food waste disposal appeared to be functional. No food was ground up in this inspection. The inspector was unable to determine if the unit will grind food waste adequately. The electrical supply wire was in a protective conduit as required.

DISHWASHER:	The dishwasher did not function when tested. The start button did not turn it on.
RANGE HOOD:	The range hood and exhaust fan appeared to work correctly on one or both speeds.
RANGE/OVEN FUEL SOURCE:	The oven was electric and the stove gas.
RANGE/OVEN:	When the stove burners were turned to their lowest setting the rear 3 did not stay lit. The oven was functional at the time of the inspection. Temperatures of heat settings were not tested.
MICROWAVE OVEN:	There was a microwave oven. The unit was tested by heating water. The unit functioned as intended.
REFRIGERATOR:	None.
WATER FOR REFRIGERATOR:	There was a water line installed for the refrigerator.
HEAT SOURCE:	There was a heat register in this room.

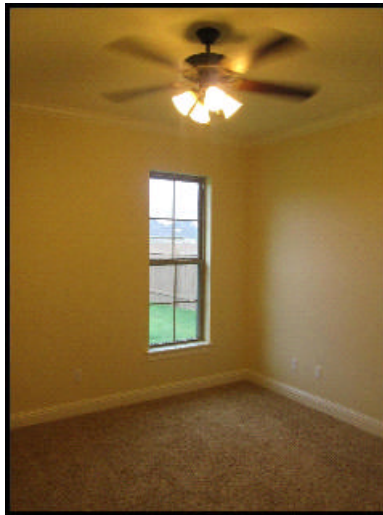
BEDROOM #1

CEILING:	The ceiling appeared to be satisfactory.
CEILING FAN:	There was a ceiling fan installed, and it appeared to be functional.
FLOOR:	The flooring appeared to be satisfactory.
ELECTRICAL OUTLETS:	The outlets tested appeared to be correctly wired and grounded.
HEAT SOURCE:	There was a heat source in this room.

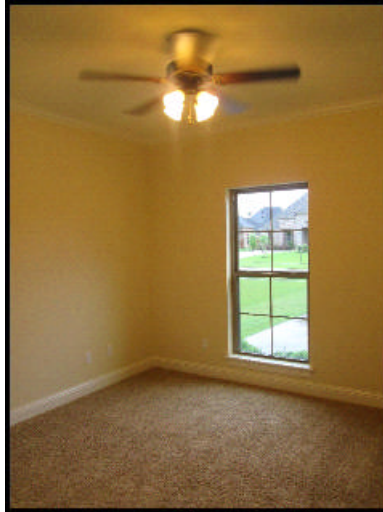
BEDROOM #2

ENTRY DOOR:	The entry door was functional.
CLOSET:	The closet was functional and of average size.
WALLS:	The walls appeared to be satisfactory.
LIGHTING:	The lighting appeared to be functional at the time of the inspection.
CEILING:	The ceiling appeared to be satisfactory.
CEILING FAN:	There was a ceiling fan installed, and it appeared to be functional.
FLOOR:	The flooring appeared to be satisfactory.
ELECTRICAL OUTLETS:	The outlets tested appeared to be correctly wired and grounded.
HEAT SOURCE:	There was a heat source in this room.

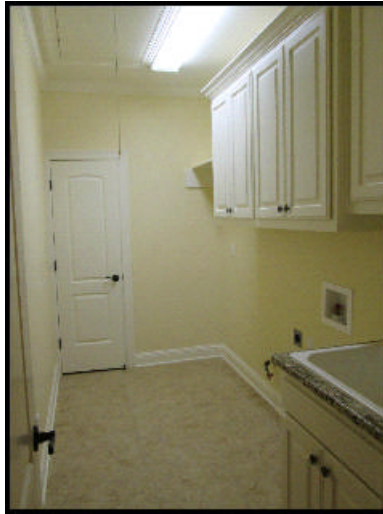
ENTRY DOOR:	The entry door was functional.
WALLS:	The walls appeared to be satisfactory.
CEILING:	The ceiling appeared to be satisfactory.
ELECTRICAL OUTLETS:	The outlets tested appeared to be correctly wired and grounded.
GROUND FAULT INTERRUPT OUTLETS:	The sink outlet was GFCI protected. The outlet intended for a refrigerator was GFCI protected. It should not be.
FLOOR:	The flooring appeared to be satisfactory.
LIGHTING:	The lighting appeared to be functional at the time of the inspection.
WASHER & DRYER:	None
WASHER HOOKUP:	There was a connection box installed in the wall with both hot and cold water and a drain pipe. The drain pipe was not flood tested.
DRYER HOOKUP:	There was a hookup for both a gas dryer and a 220-volt electric dryer.
DRYER VENTILATION:	The dryer ventilation as installed appeared to be adequate.
LAUNDRY BASIN:	There was a laundry basin installed. The unit appeared to be functional. No leaks were noted.

CABINETS:	The cabinets were functional.
HEAT SOURCE:	There was a heat source in this room.

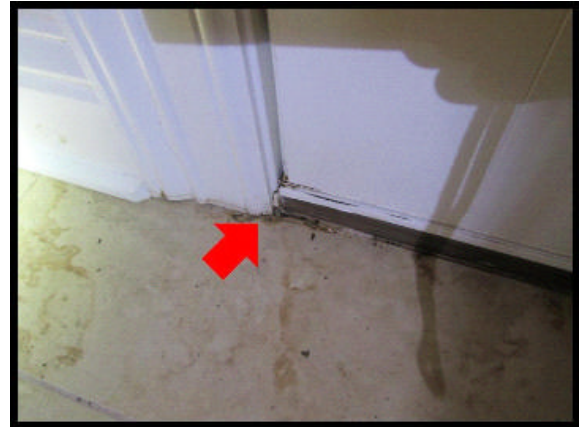
OTHER ENTRY DOORS:

The other front entry door seeped water through the lower corners of the door. Example pictured. The rear door appeared to be in functional condition.

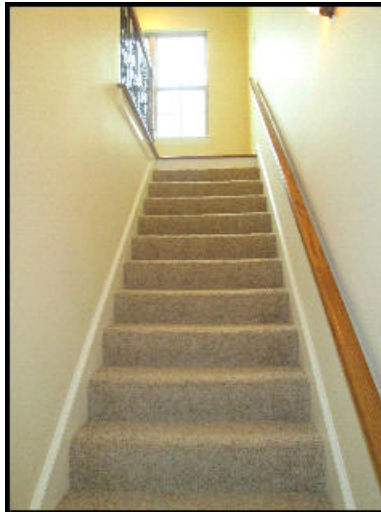
MAIN STAIRCASE:

The staircase appeared to be appropriately installed. There was a handrail installed. The staircase appeared to be adequately lighted.

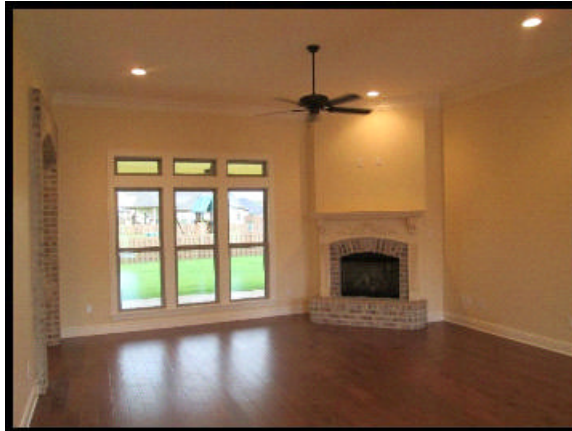
WALLS:	The walls appeared to be satisfactory.
CEILING:	The ceiling appeared to be satisfactory.
CEILING FAN:	There was a ceiling fan installed, and it appeared to be functional.
FLOOR:	The flooring appeared to be satisfactory.
LIGHTING:	The lighting appeared to be functional at the time of the inspection.
ELECTRICAL OUTLETS:	The outlets tested appeared to be correctly wired and grounded.
HEAT SOURCE:	There was a heat register in this room.

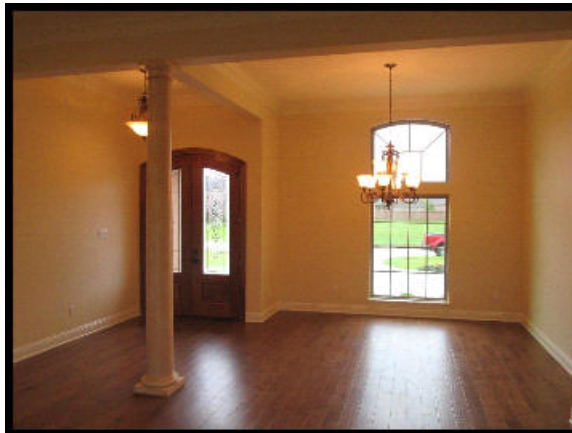
DINING ROOM / FOYER

WALLS:	The walls appeared to be satisfactory.
CEILING:	The ceiling appeared to be satisfactory.
FLOOR:	The flooring appeared to be satisfactory.
LIGHTING:	The lighting appeared to be functional at the time of the inspection.
ELECTRICAL OUTLETS:	The outlets tested appeared to be correctly wired and grounded.
HEAT SOURCE:	There was a heat register in this room.

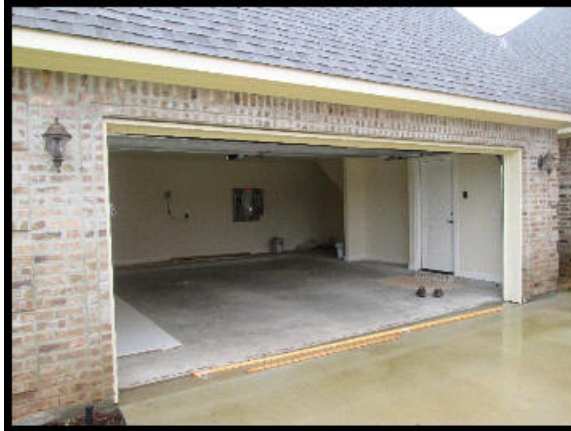
GENERAL GARAGE CONDITION

The garage was attached.

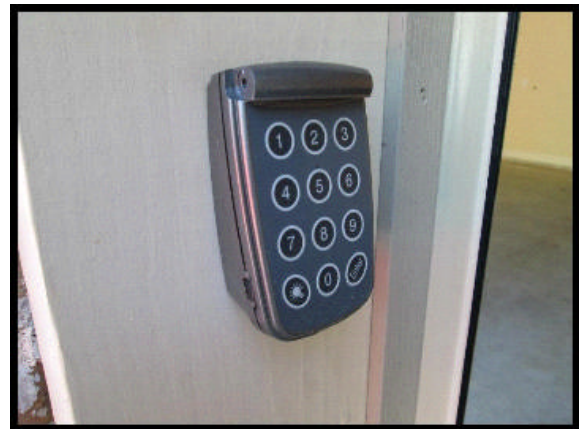
AUTOMATIC OVERHEAD DOOR

The overhead door opener appeared to function appropriately. **The cover was missing from the exterior door opener key pad.**
